Chapter 3

Transboundary and cross-border environmental issues in Uganda

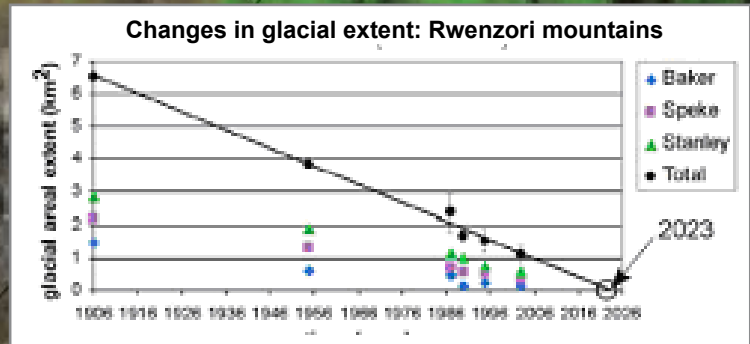
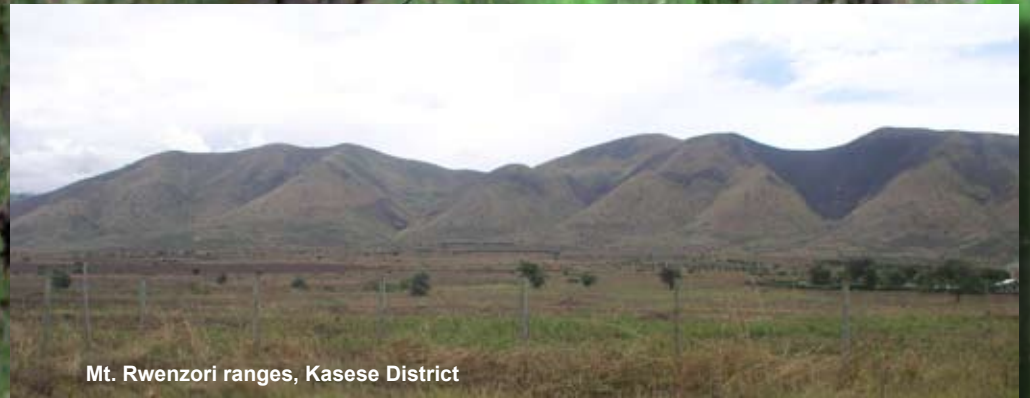
Mt. Rwenzori Glaciers

Global warming,
disappearing ice
caps,
reduced stream
water

If global warming persists, ice cover on the peaks of the Rwenzoris (Baker, Speke and Stanley) will disappear altogether by 2023 (Mileham et al in press). In 1987 there was more snow on the Stanley, Baker and Speke peaks but by 2005 there are strong signs of reduction in snow. The disappearance of the ice cover will mean reduced water

flow in the receiving streams which feed into Lakes George and Edward and Semliki River, discharging water into Lake Albert and finally into the Nile. The biodiversity and tourism potential of the Rwenzori will also be affected.

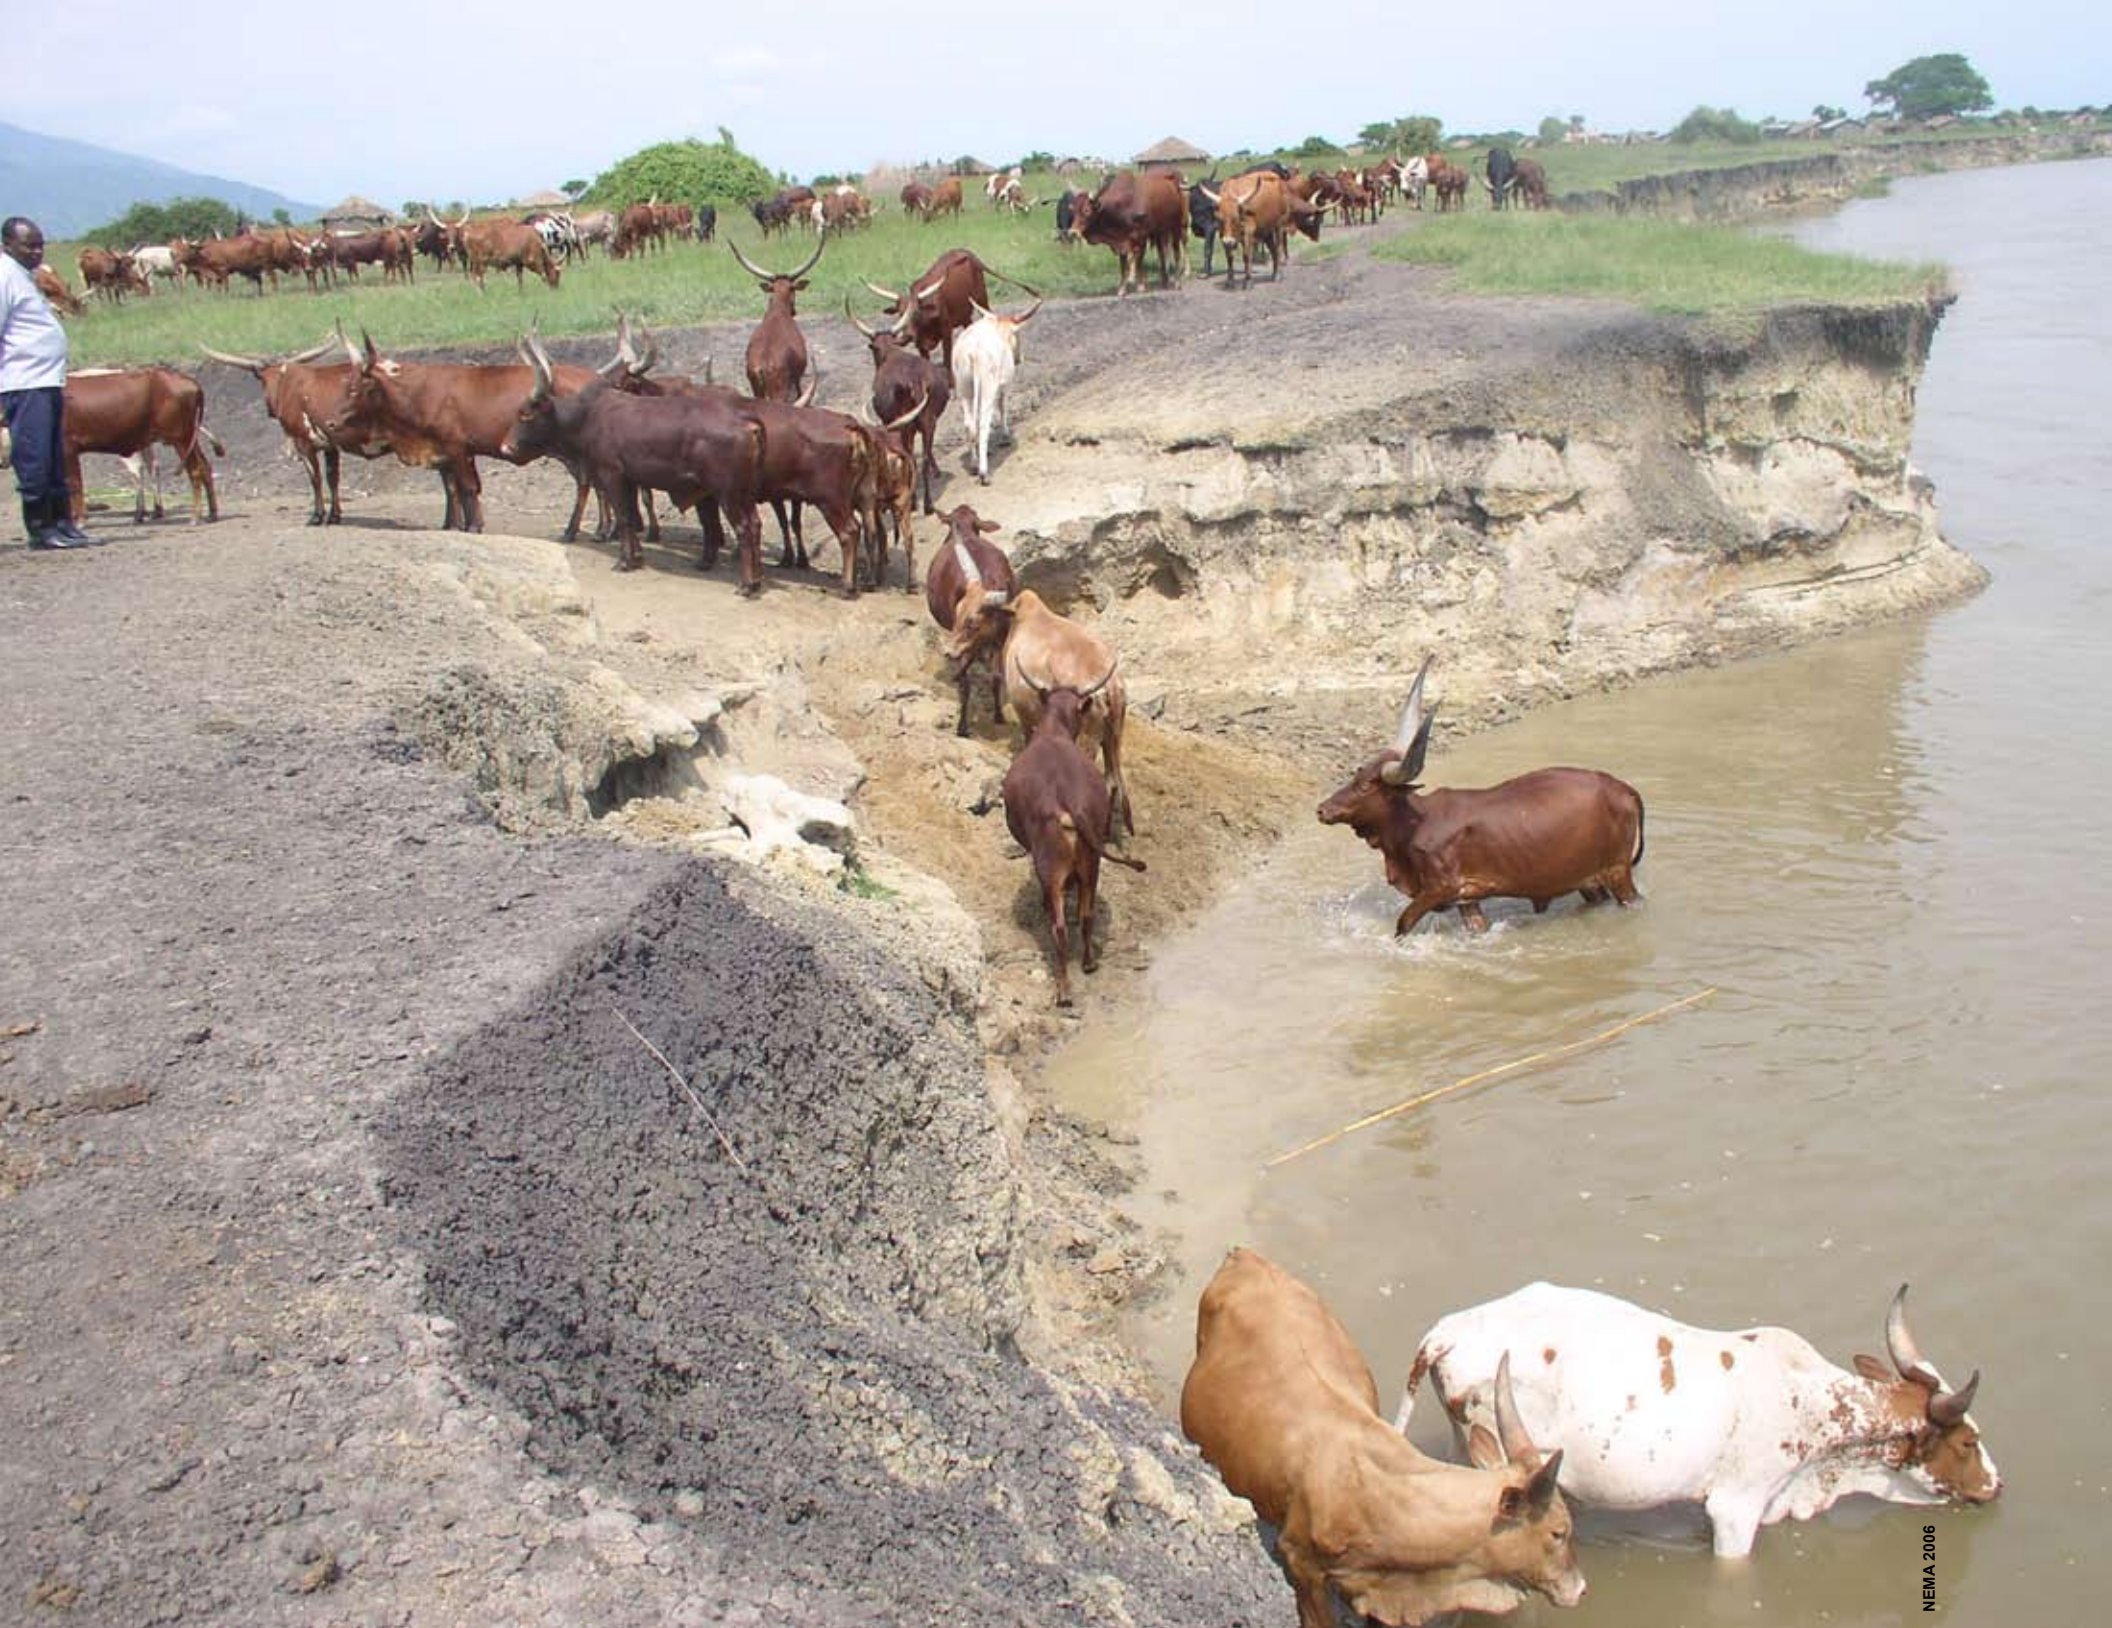
A herd of cattle grazing and watering at the banks of River Semliki

Increased river bank erosion due to overgrazing, melting of ice on the Mount Rwenzori and degradation of the water catchments has resulted in siltation changing the river course significantly over the years as it enters Lake Albert.

District. This approximately 100 km long section of the river in the Semliki flats has seriously eroded its banks. The local communities along the river are cattle keepers who graze along and collect water from the same river. On the Uganda side, the town of Rwebisengo is only 1.5 km away from the river and there are numerous other homesteads along it. The human and livestock activities have greatly affected the natural vegetation along its course, thus leading to river bank breakage. Over 10 m of the river bank on Uganda's territory is eroded annually at various points and as a result, it seems to have doubled its width within the last ten years.

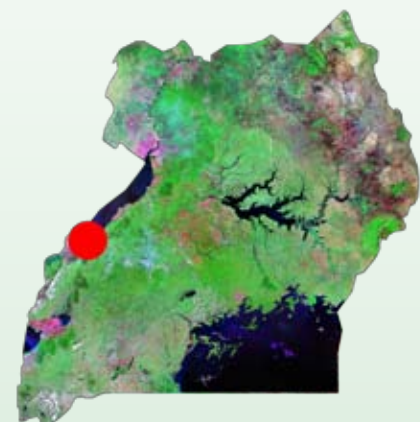
Delta Front

- 1937
- 2008

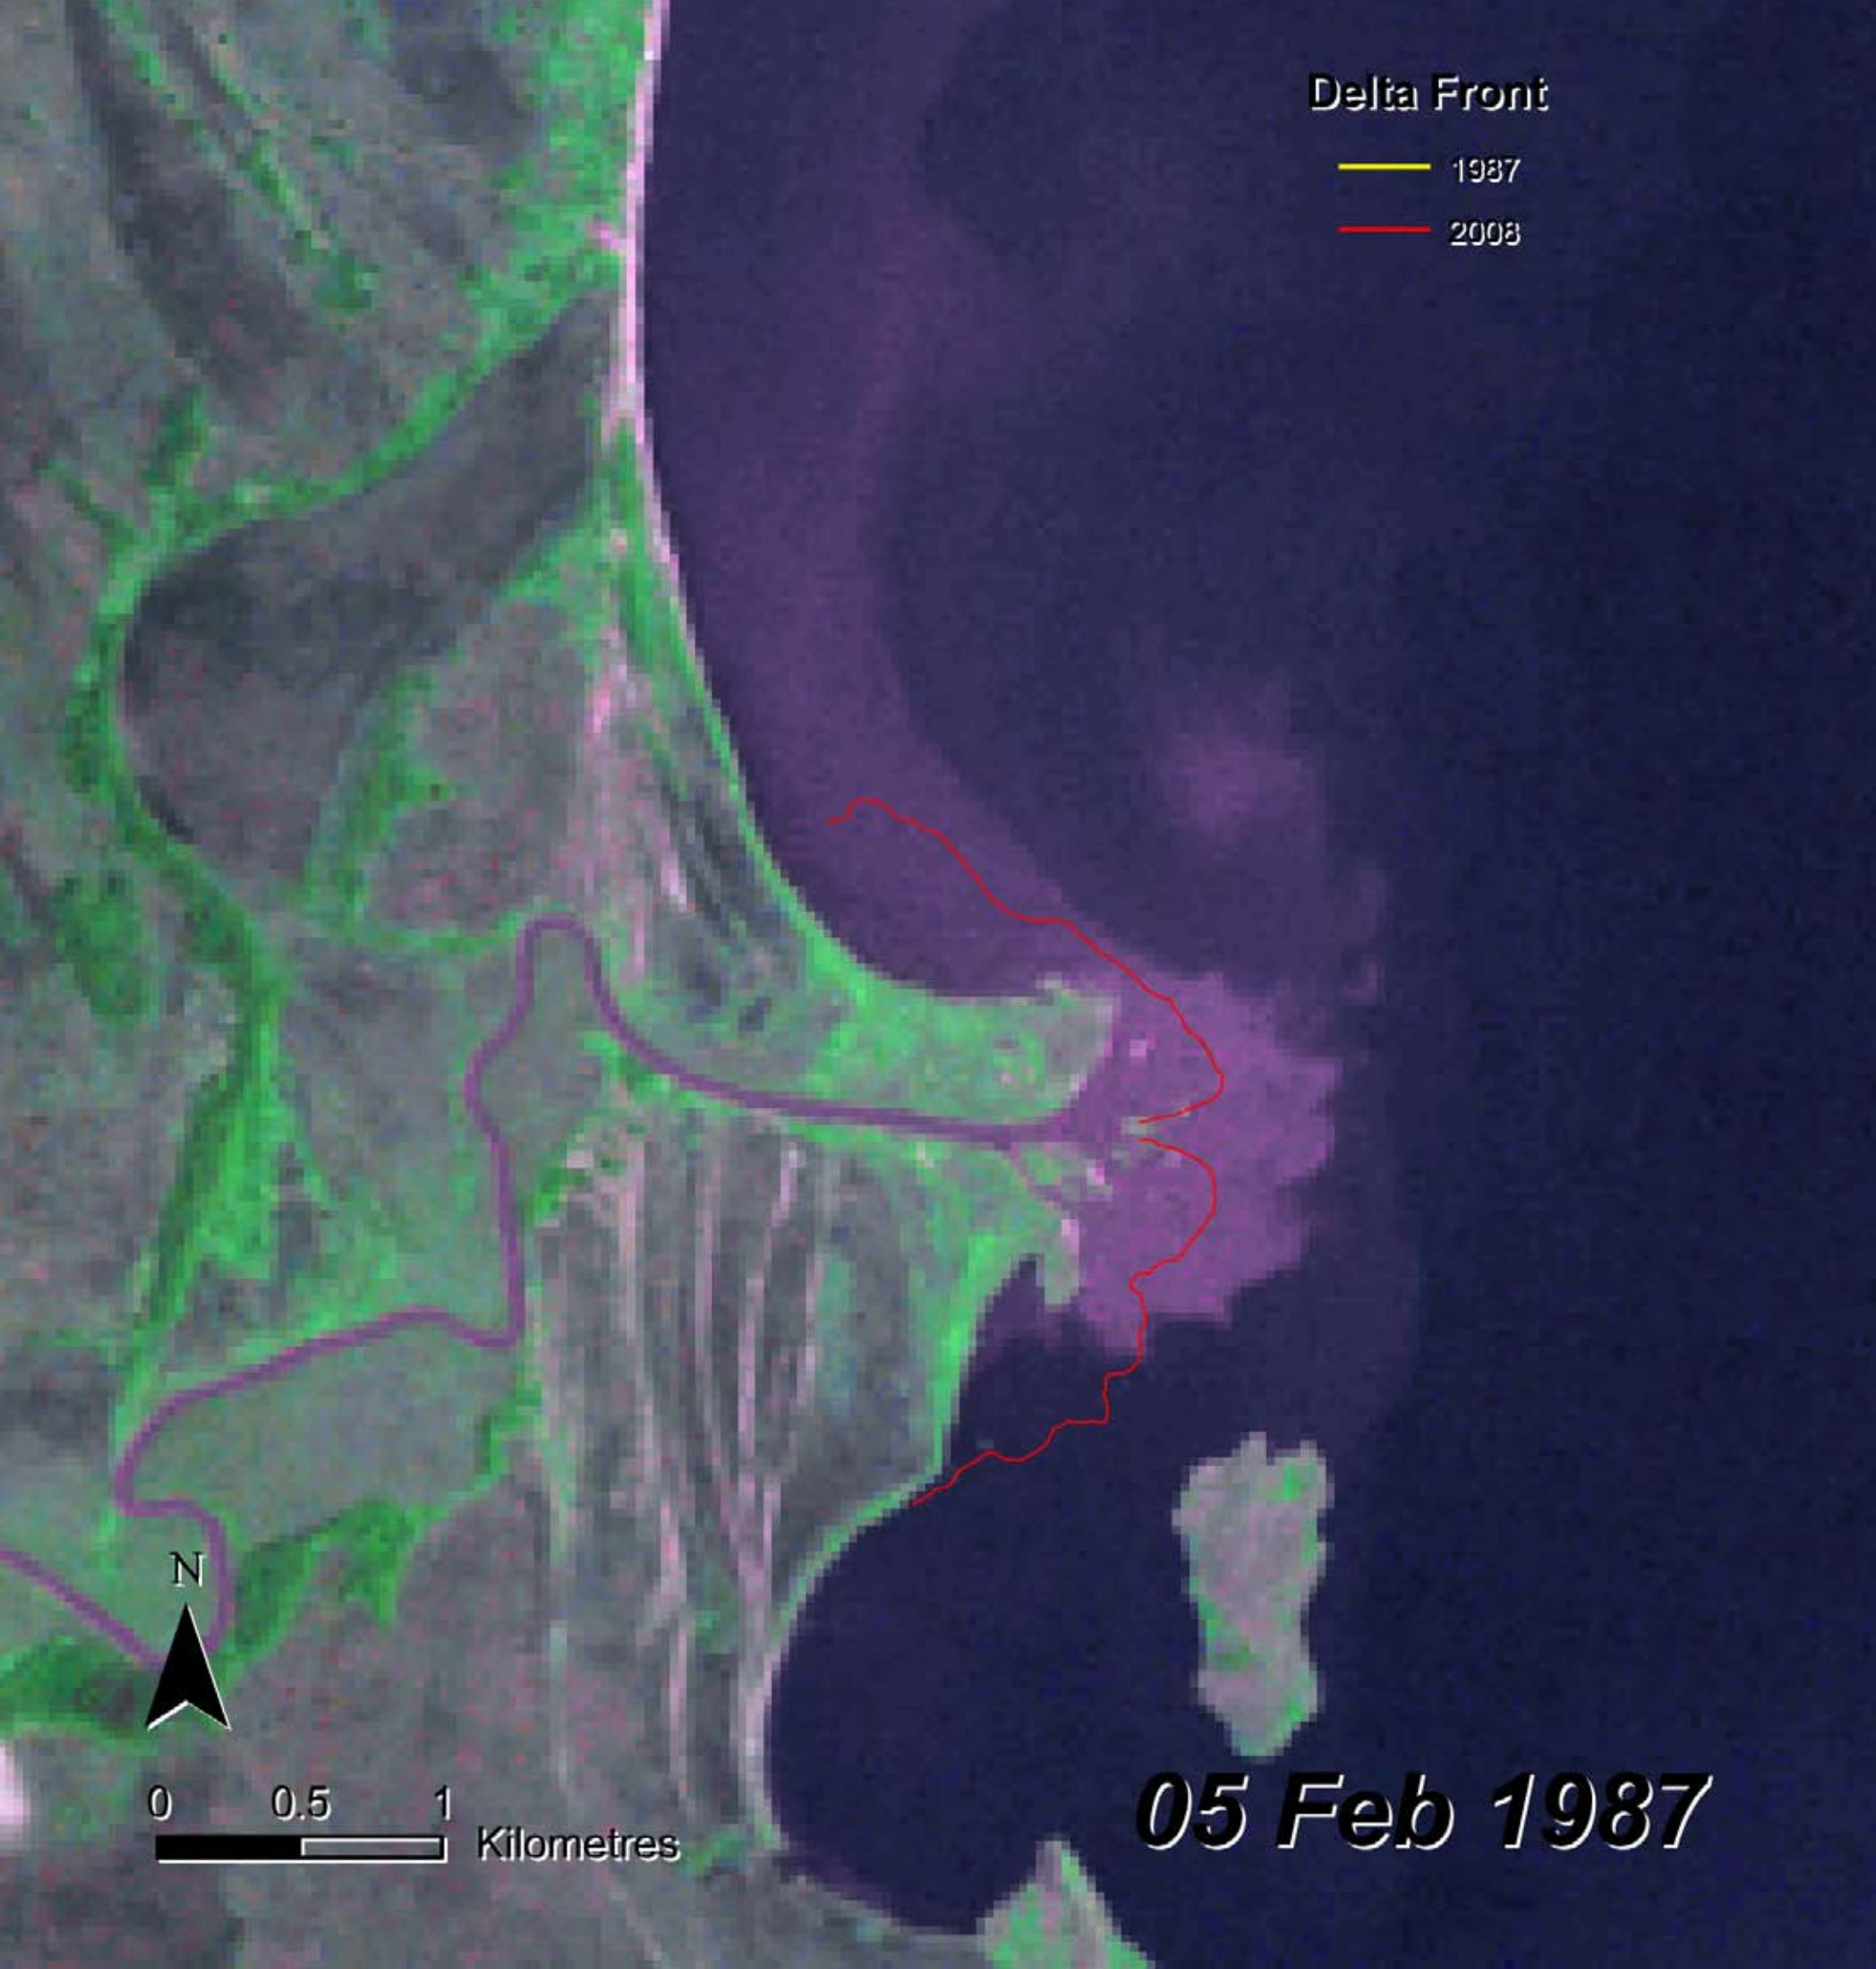
Changing river course of the River Semliki

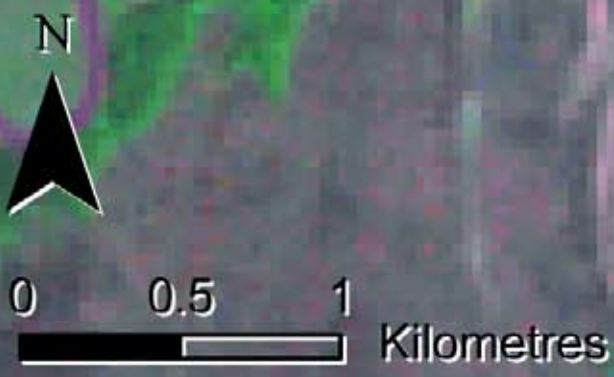
05 Feb 1987

The Kagera River which originates from Burundi, and forms the Rwanda-Tanzania, Tanzania-Uganda borders is the largest contributor of water from the catchments. The satellite images of 1987 and 2008 show high reflectance of water from the Kagera River due to silt. Silt and suspended solids impact on water bodies by loading nutrients into the lake. Nutrients stimulate algae growth which reduces oxygen leading to eutrophication and reduction in fish. Siltation is mostly associated with agricultural activities. The delta at the mouth of the river has shifted more into the lake and it is likely to join with the small island below the mouth of the river (circled).

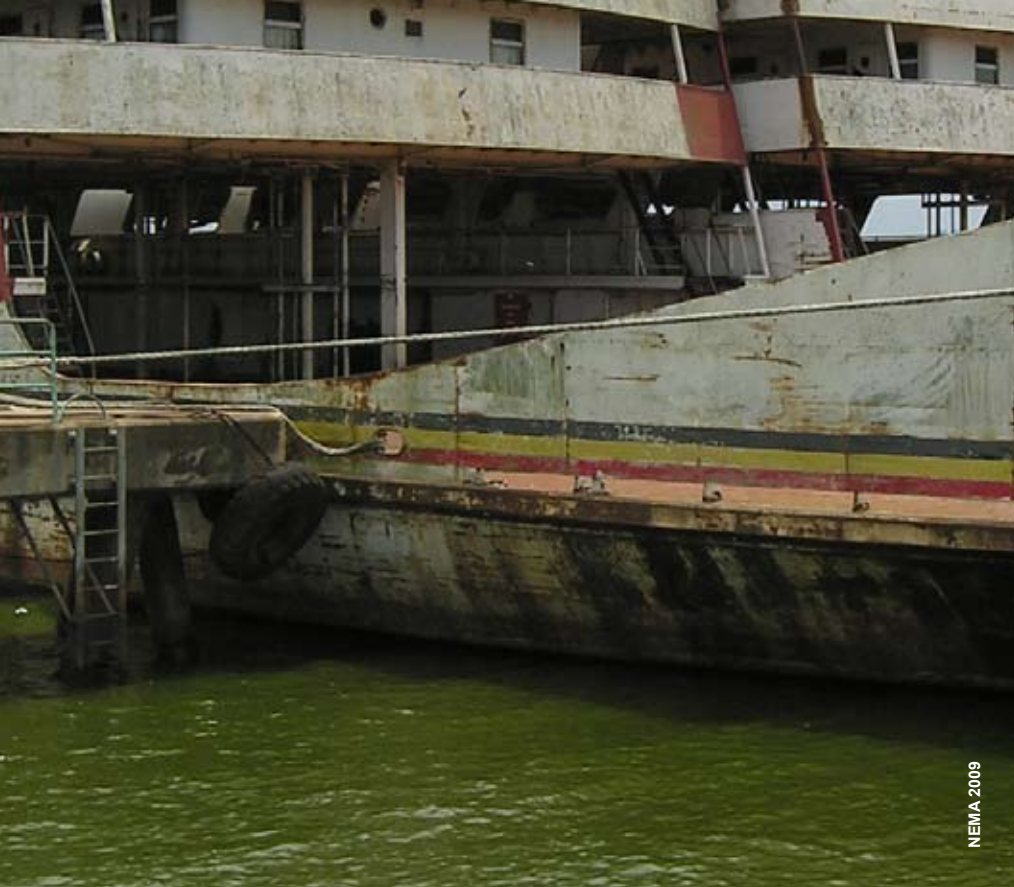
The Kaawa ship docks on the Green algae bloom contaminated waters of Lake Victoria at the Port Bell port, near Kampala.

Water quality in Lake Victoria has declined greatly in the past few decades, owing chiefly to eutrophication arising from increased inflow of nutrients into the lake. Nutrient inputs have increased two to three-fold since the turn of the century, mostly since 1950. Concentrations of phosphorus have risen markedly in the deeper lake waters, and so has nitrogen around the edges. Stimulated by these and other nutrients, the five-fold increase in algae growth since 1960, and the shift in its composition towards domination by blue-green algae, are causing deoxygenation of the water,

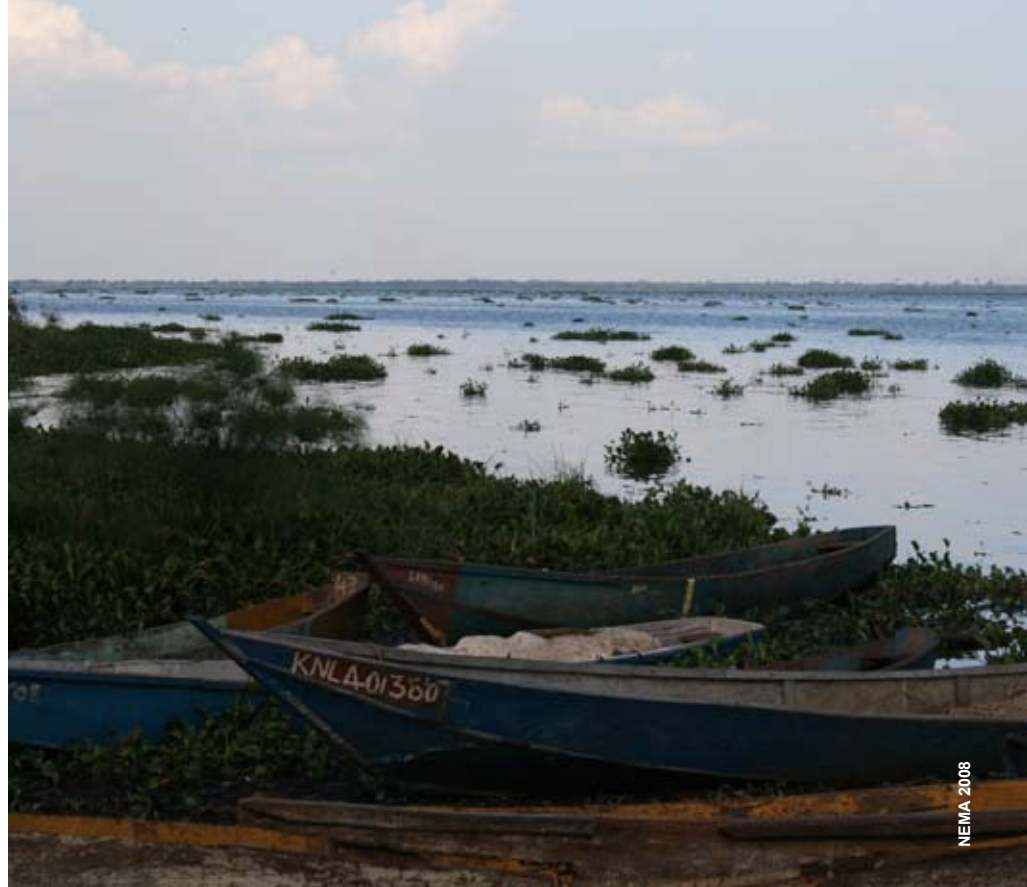
Water hyacinth at the shores of Lake Kyoga, Zengebe, Nakasongola District. The plant has devastating impacts on water bodies, aquatic biodiversity and people's livelihoods.

increased sickness to humans and animals drawing water from the lake, clogging of water intake filters, and increased chemical treatment costs for urban centers. Aside from the near-total loss of the deepwater species, the deoxygenating of the lake's bottom waters now poses a constant threat, even to fish in shallower portions of the lake, as periodic upwelling of hypoxic water causes massive fish kills. The increased nutrient loads have also spurred the water hyacinth infestations. In addition, massive blooms of algae have developed, and come increasingly to be dominated by the potentially toxic blue-green variety. The distance at which a white disc is visible from the surface, (a transparency index measuring alga abundance), has declined from 5 meters in the early 1930s to one meter or less for most of the year in the early 1990s. Water-borne diseases have increased in frequency. Water hyacinth, absent as late as 1989, has begun to choke important waterways and landings, especially in Uganda.

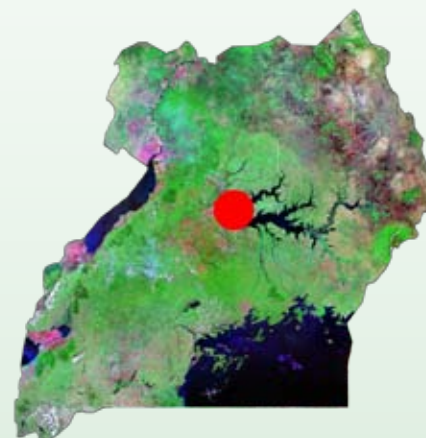
in the early 1960s that resulted in considerable expansion of open water areas of the lakes. Water levels and lake surface area declined in a fluctuating manner during the next two decades until a second major flood event occurred as a result of El Niño rains in 1997/98. The satellite images of 1986 and 2002 show the floating suddes on the lake. By 2002 the outlet of the Nile had been blocked leading to flooding on some of the shore lines. Evidence of flooding can be seen at point A of 1986 and 2002 images respectively.

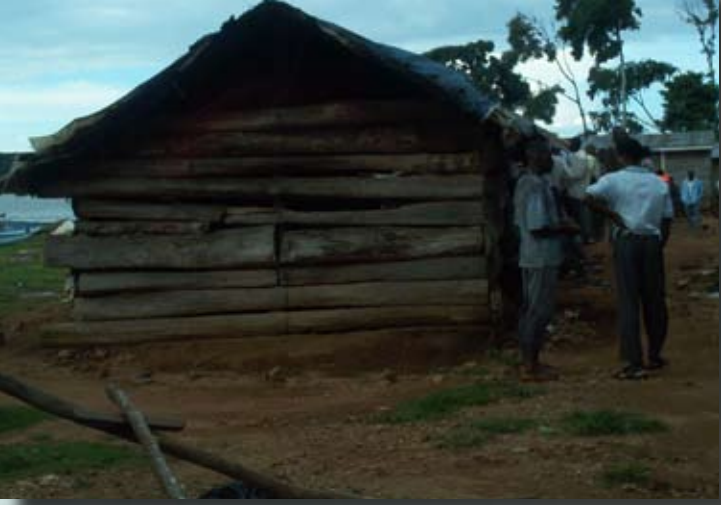
Above: Illegal settlements on the sudds. Inset: A 'Film hall'. Communities at the sudds lead reckless lives.
Below: Technical staff inspecting the sudds and catchments.

is narrow and this caused the suddes to jam and form a blockage in early 1998. As more floating suddes continued to drift downstream, they added to the bottleneck, forming a papyrus blockage 16 km long and over 80 km² in area (satellite image of 2002). This vegetative blockage slowed water flow from the Nile outlet and raised water levels by 2m in 1999-2000. Two channels were opened by the Directorate of Water Development (DWD) in 2001-2002 and later on a team from Egypt had to dredge to allow water flow downstream.

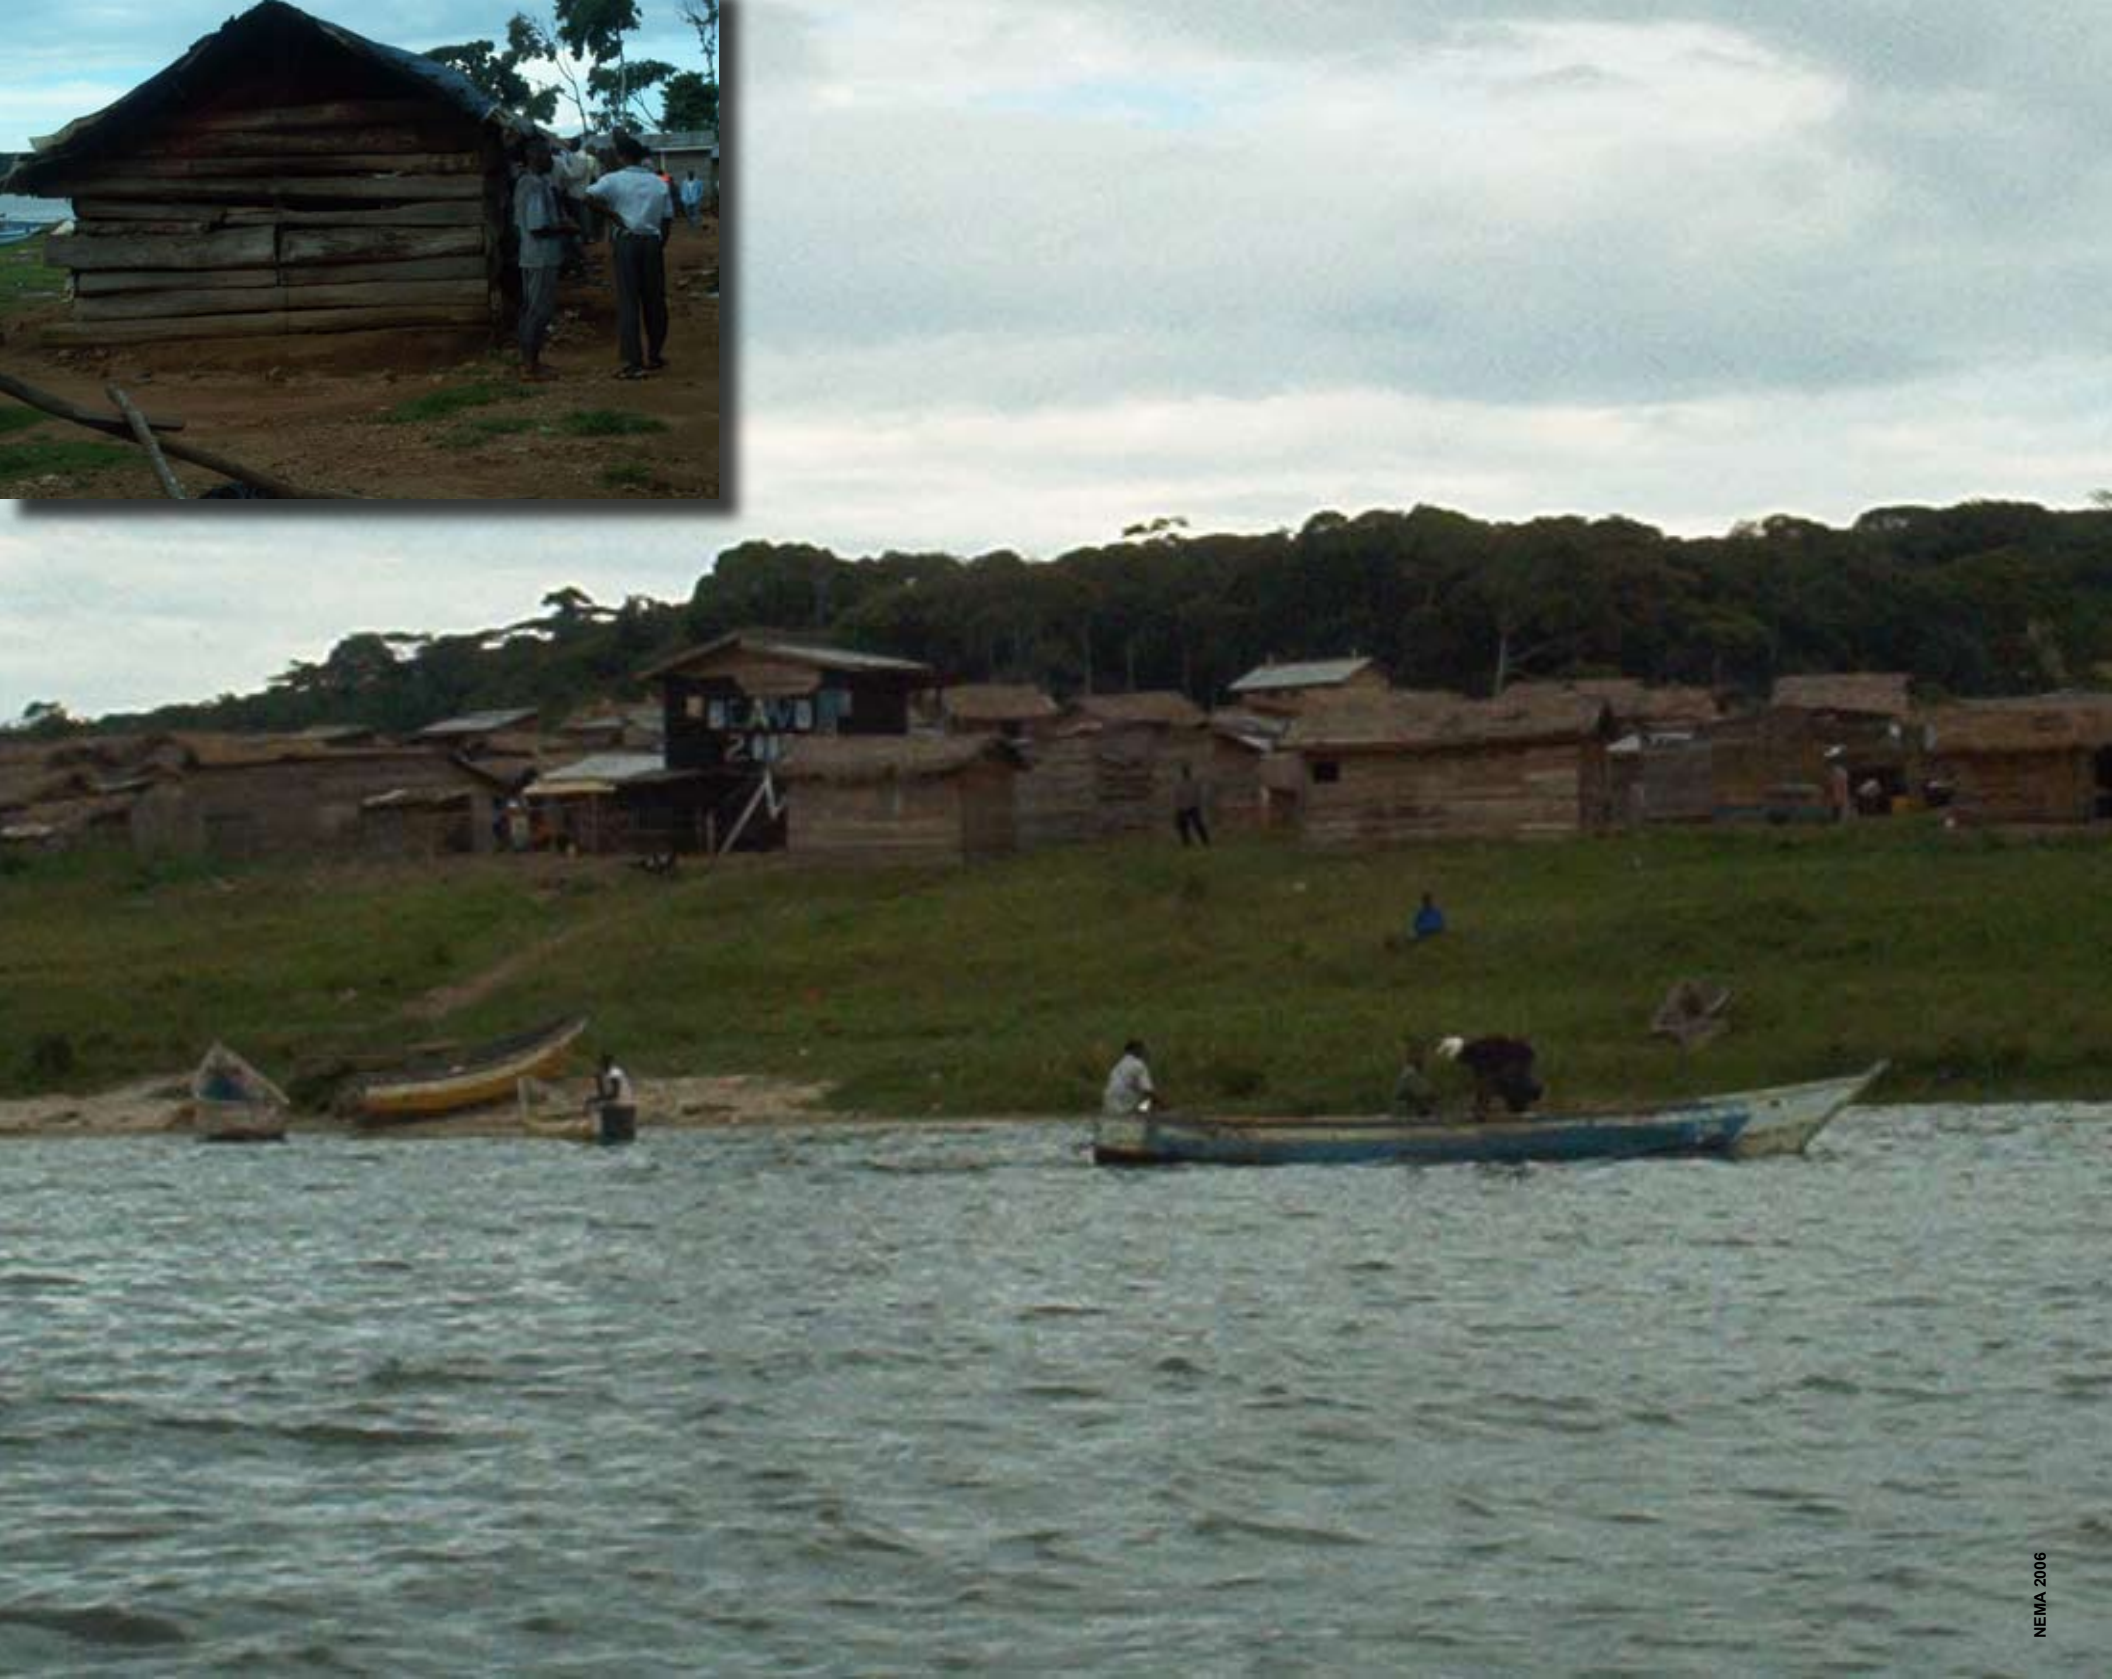
Sudds and blockage of the River Nile on Lake Kyoga
